2012 USA Pro-Cycle Challenge Pre/Post Race  
Resource Condition Assessment  
Photo Point Monitoring – Summary Report

Prepared by Deonne VanderWoude and Ann Lezberg  
Resource Monitoring Technicians  
City of Boulder  
Open Space and Mountain Parks Department  
September 2012

# 2012 USA Pro-Cycle Challenge Pre/Post Race Resource Condition Assessment – Summary Report

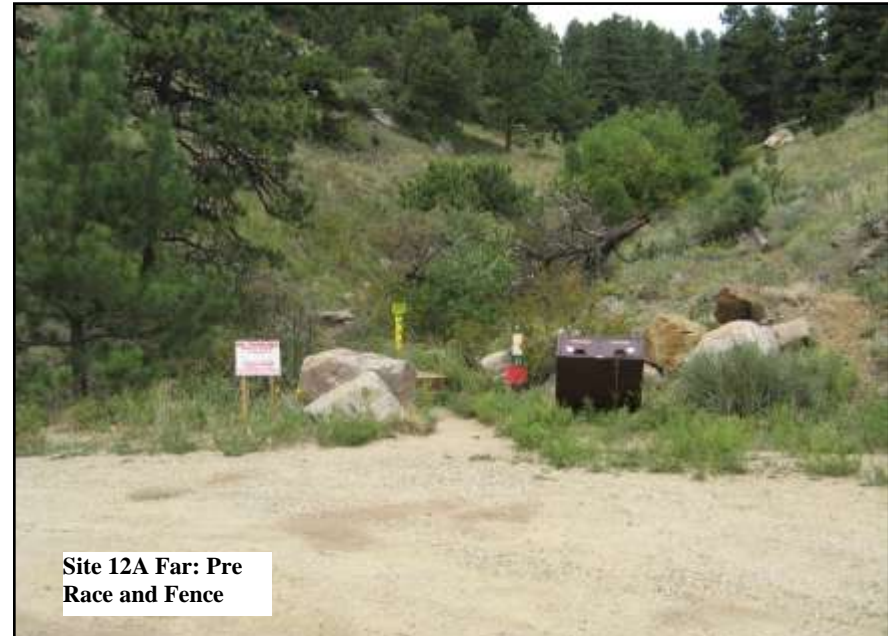
Results: No noticeable effect from fence placement or spectator activity

Note(s): Roadside viewing area

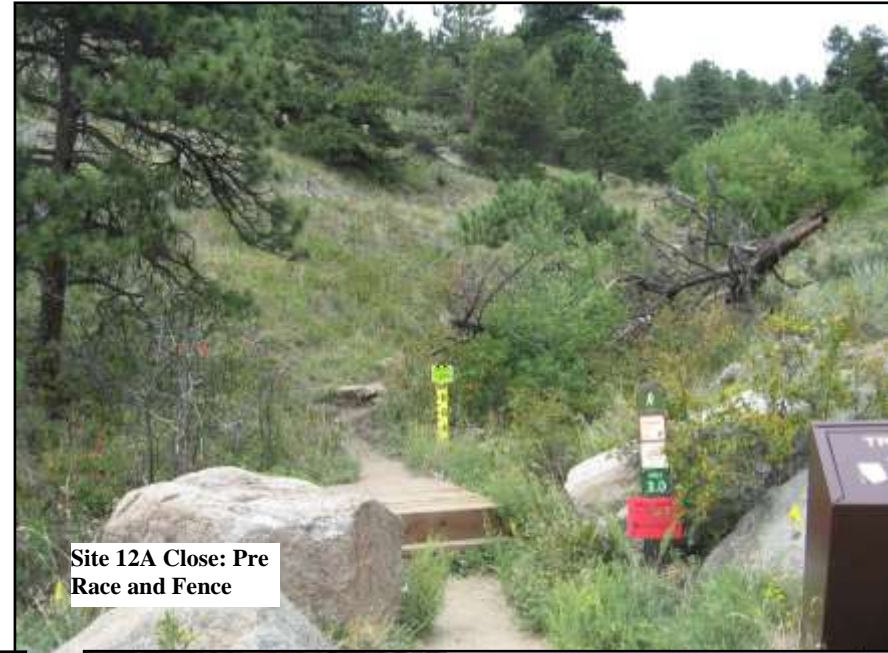
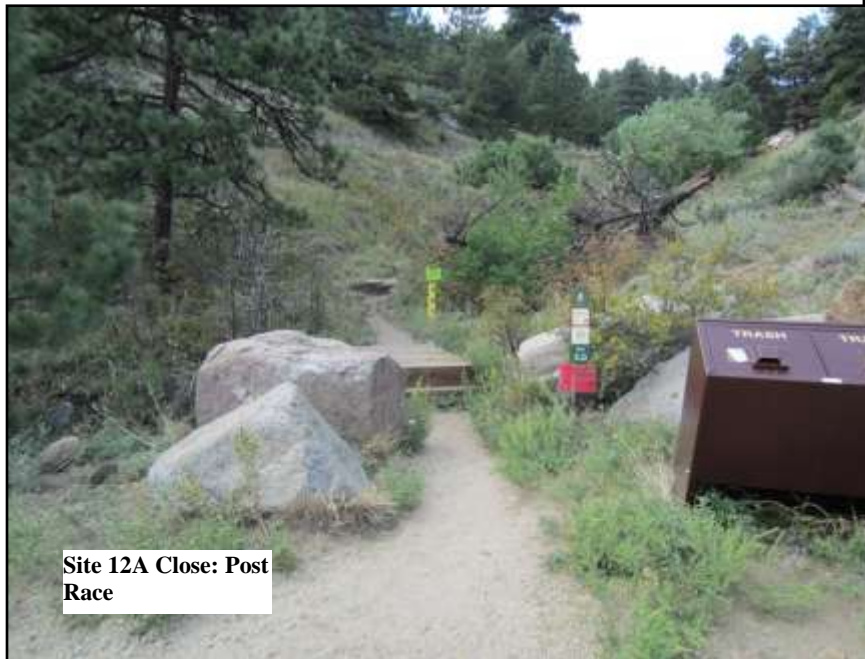
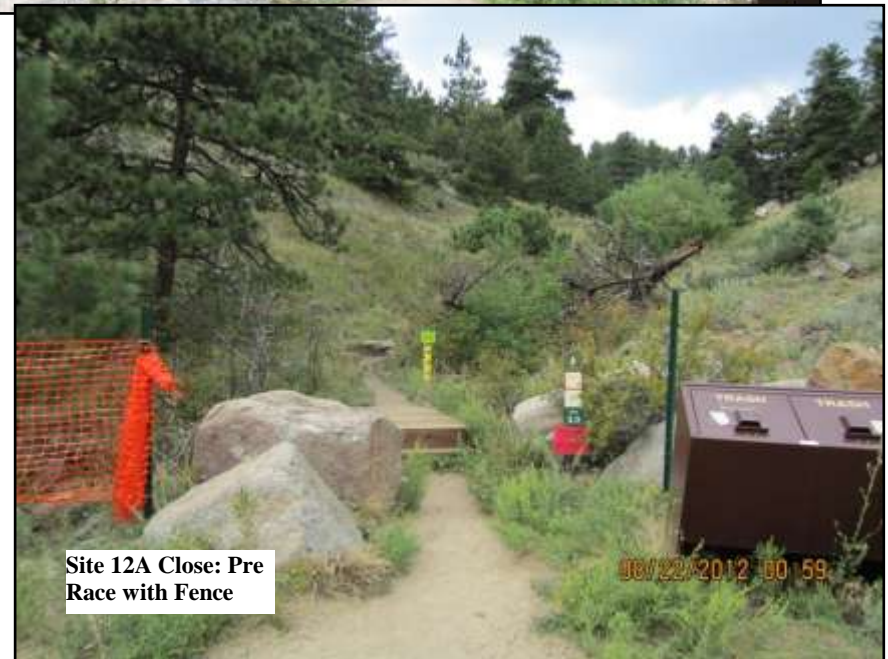
## 2012 USA Pro-Cycle Challenge - Site ID 12A Close Center

Results: No noticeable effect from fence placement or spectator activity

Note(s): Roadside viewing area

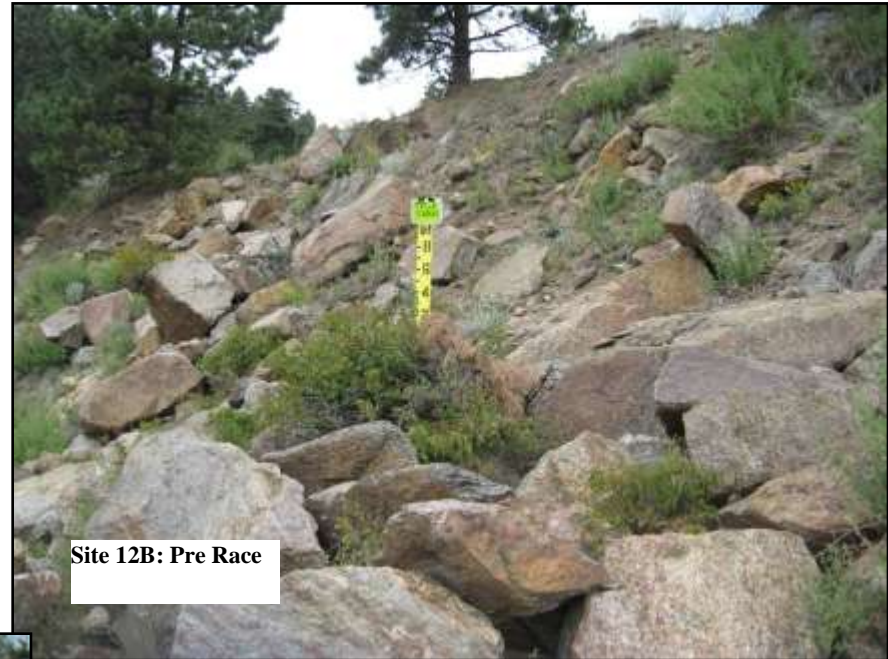
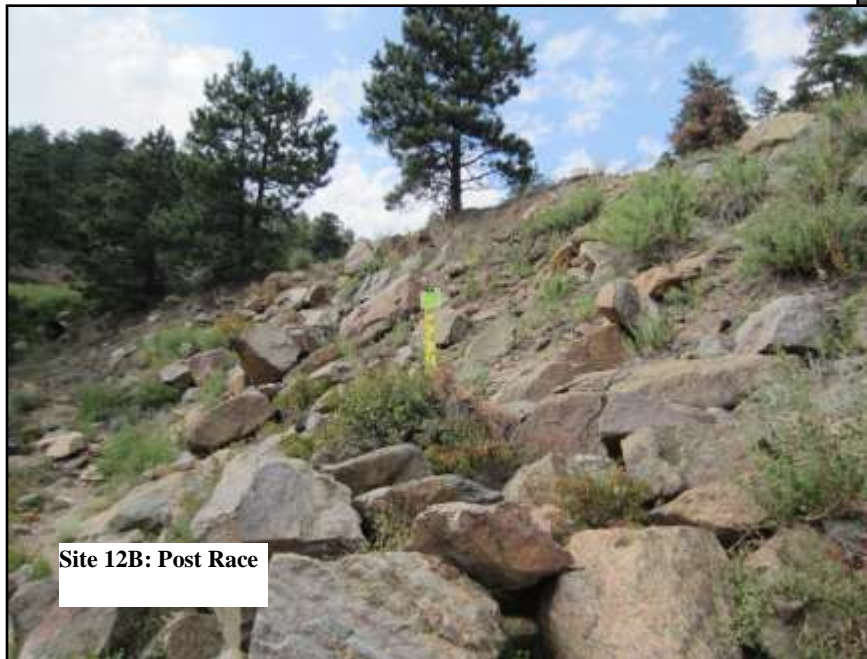
## **2012 USA Pro-Cycle Challenge - Site ID 12B Center**

Results: No noticeable effect from spectator activity

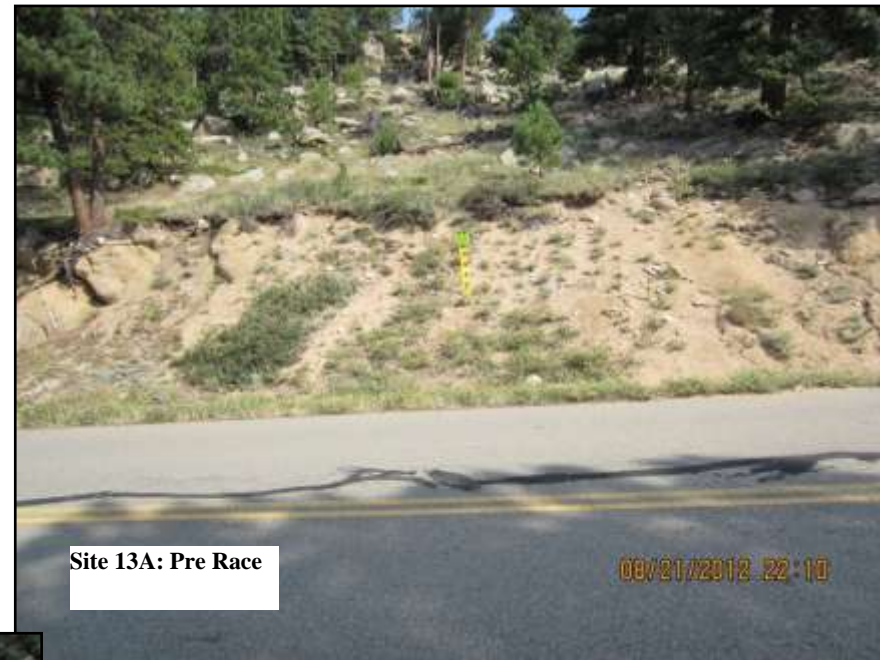
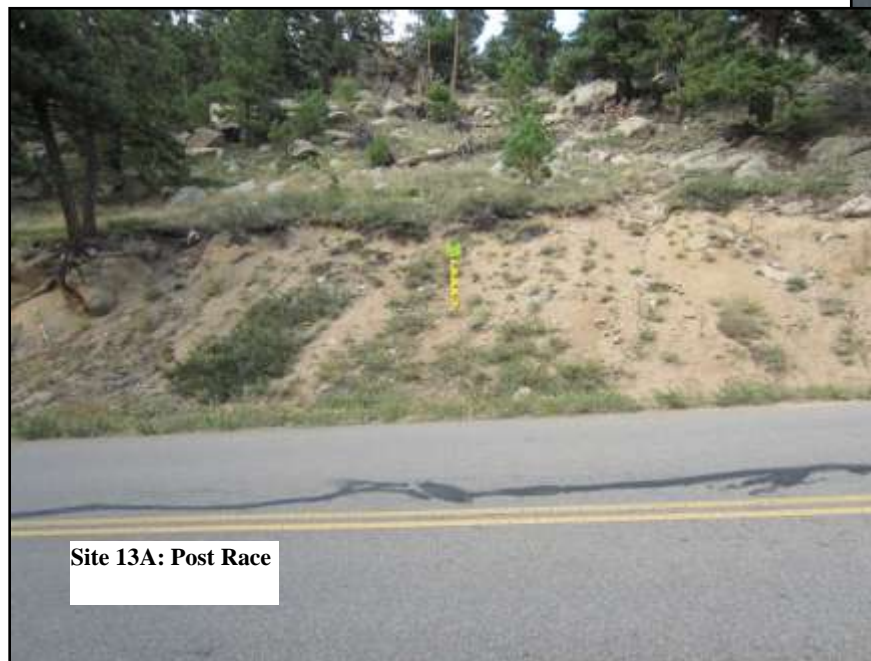
## 2012 USA Pro-Cycle Challenge - Site ID 13A Center

Results: No noticeable effect from spectator activity

Note(s): Roadside viewing area

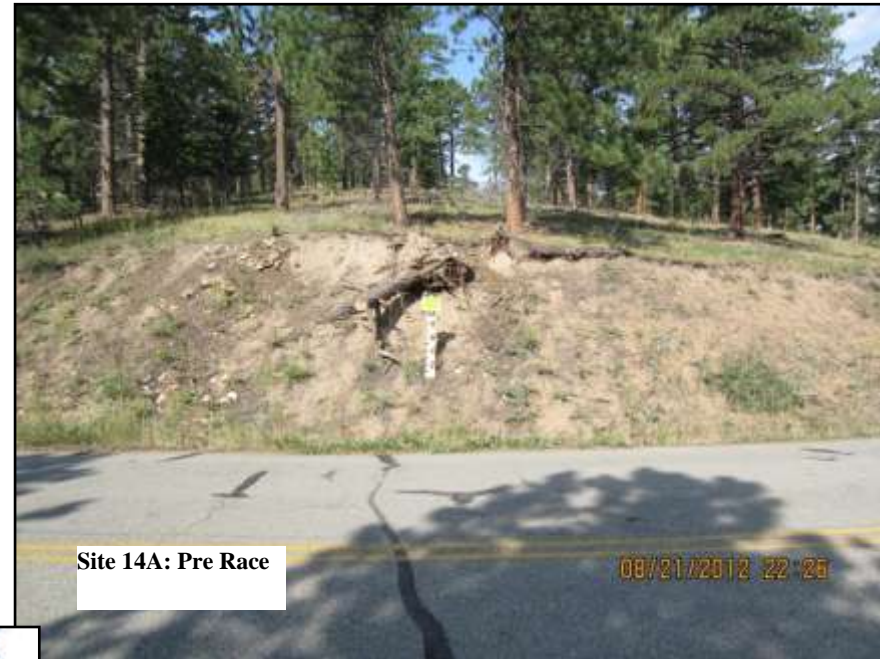
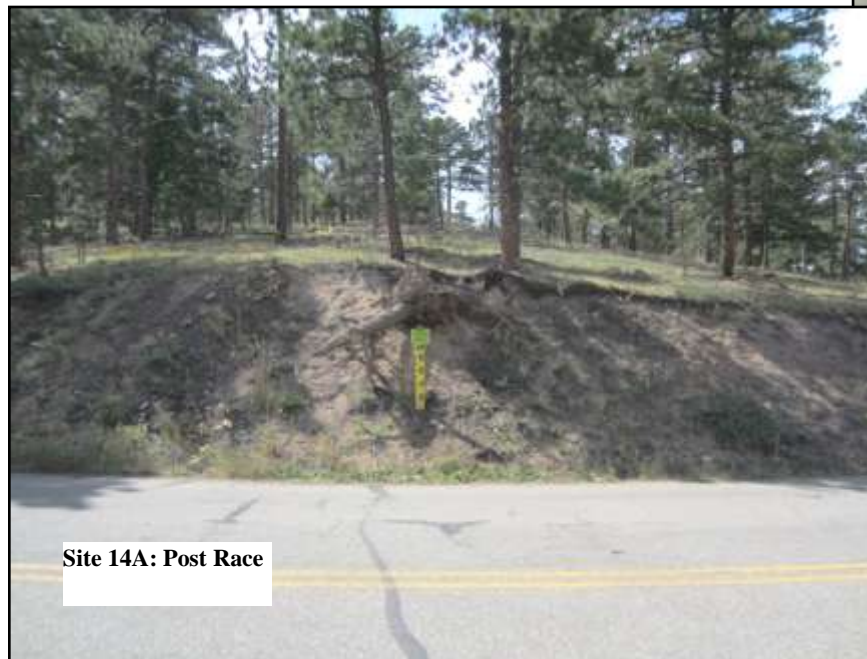
## 2012 USA Pro-Cycle Challenge - Site ID 14A Center

Results: No noticeable effect from spectator activity

Note(s): Roadside viewing area

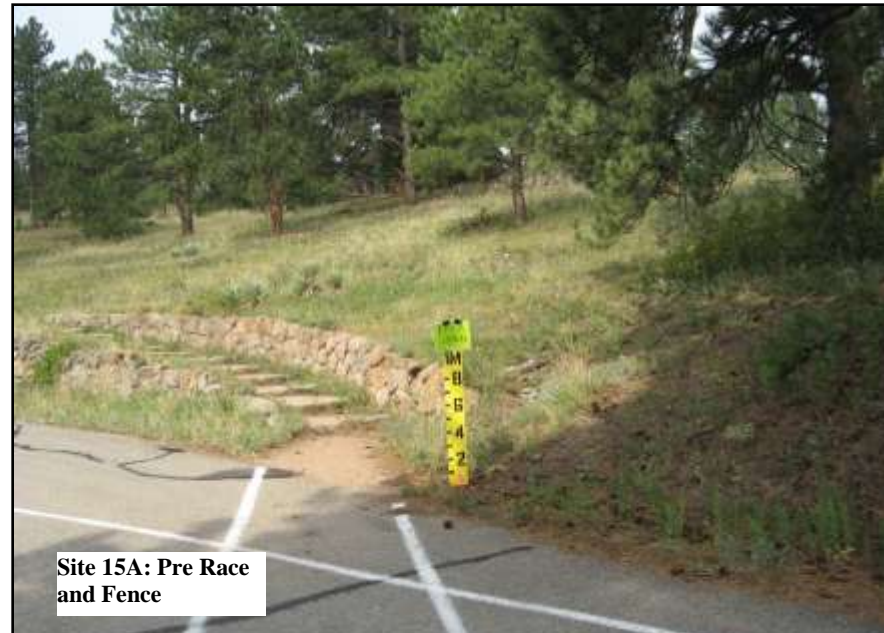
Site 15A: Pre Race and Fence

Results: Some noticeable change from finishing corral placement or spectator activity

Note(s): Some vegetation loss and additional exposed soil

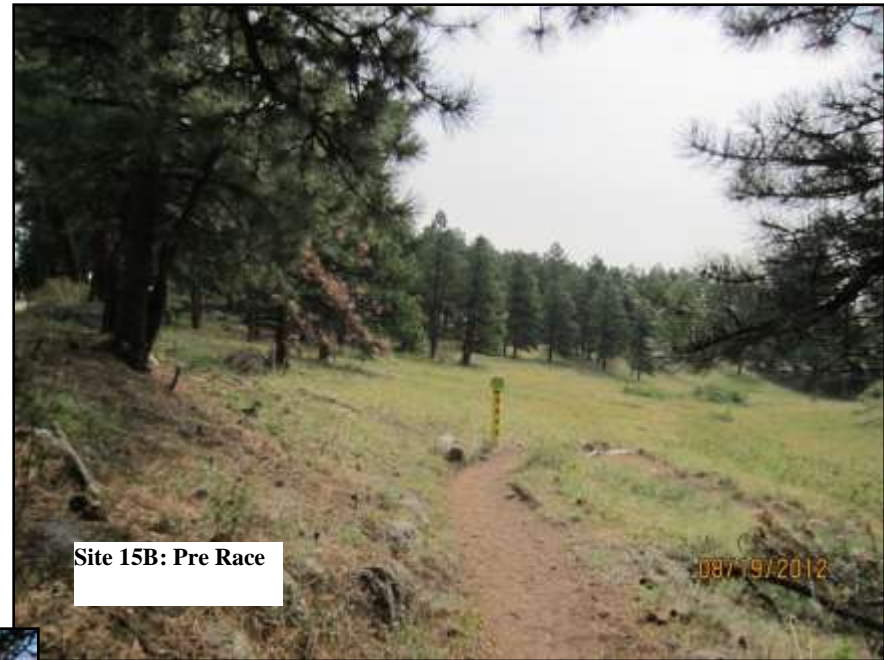
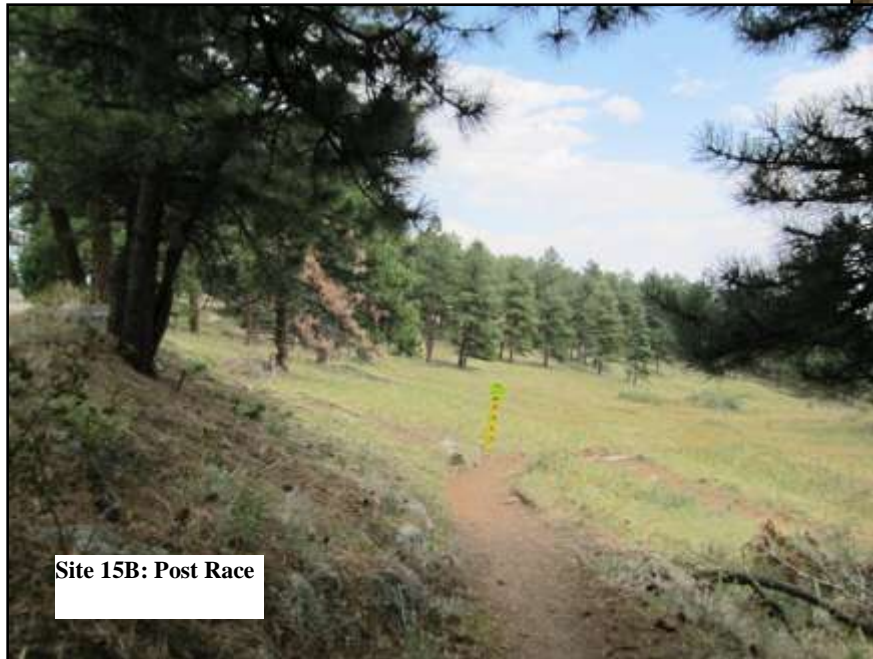
## 2012 USA Pro-Cycle Challenge - Site ID 15B Center

Results: No noticeable effect from spectator activity

- If monitoring is repeated, the following recommendations would improve the project's benefit, effectiveness and efficiency:
  - Eliminate photo points 1A, 5A, 8A, 8C, 10B, 11A, 15B and 19B. These are unlikely to show change in conditions because visitor travel off road or trail is already restricted by fence placement and trailside conditions or because terrain is resistant to visitor travel.

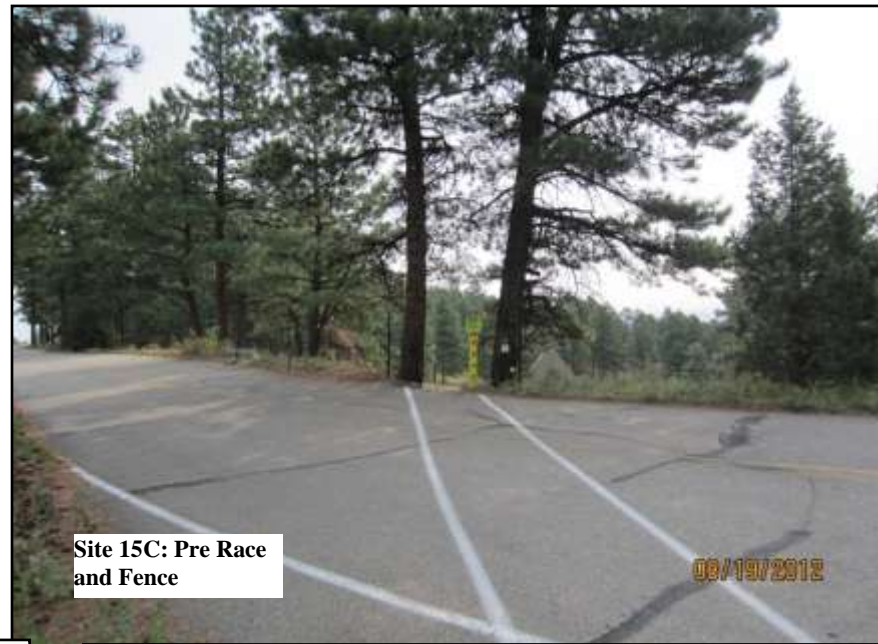
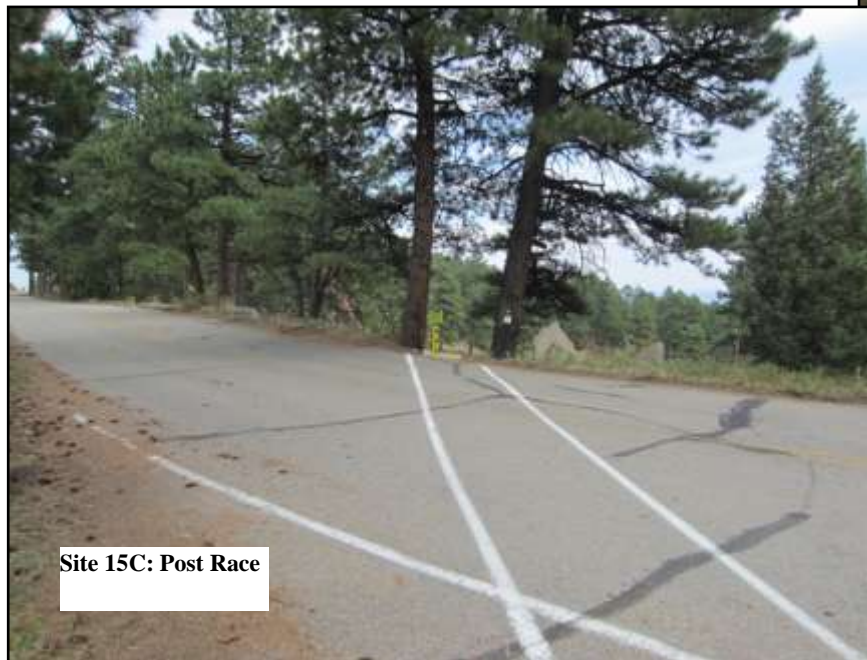
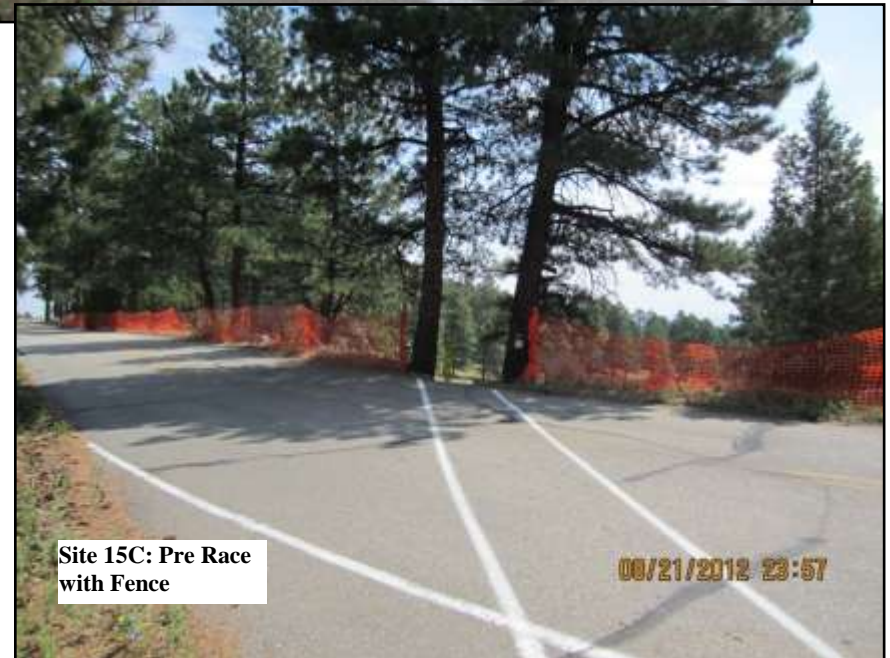
## 2012 USA Pro-Cycle Challenge - Site ID 15C Center

Results: Some noticeable change from finishing corral placement, fence placement or spectator activity

Note(s): Some vegetation loss and additional exposed soil; duff and organics spread inward on roadway

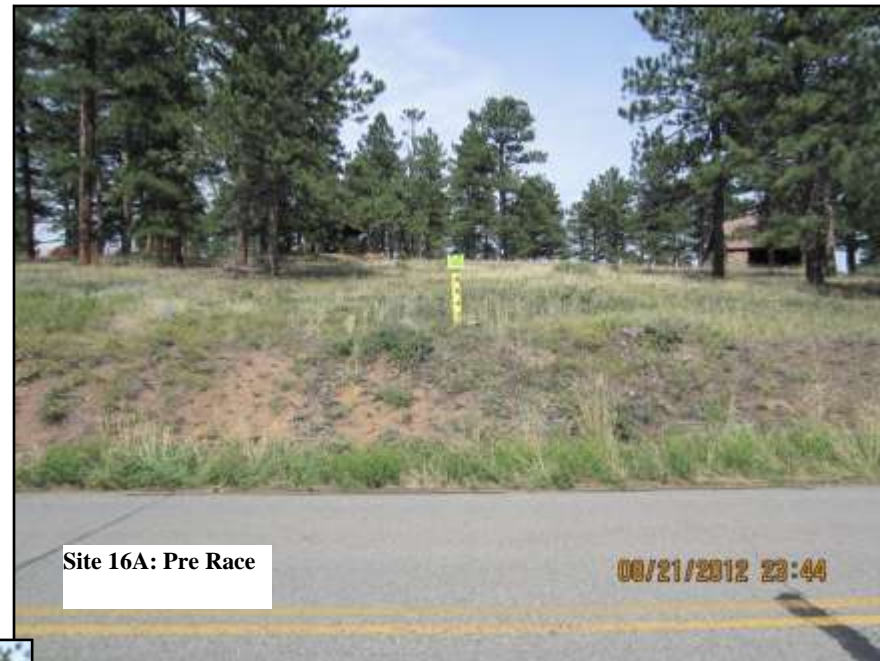
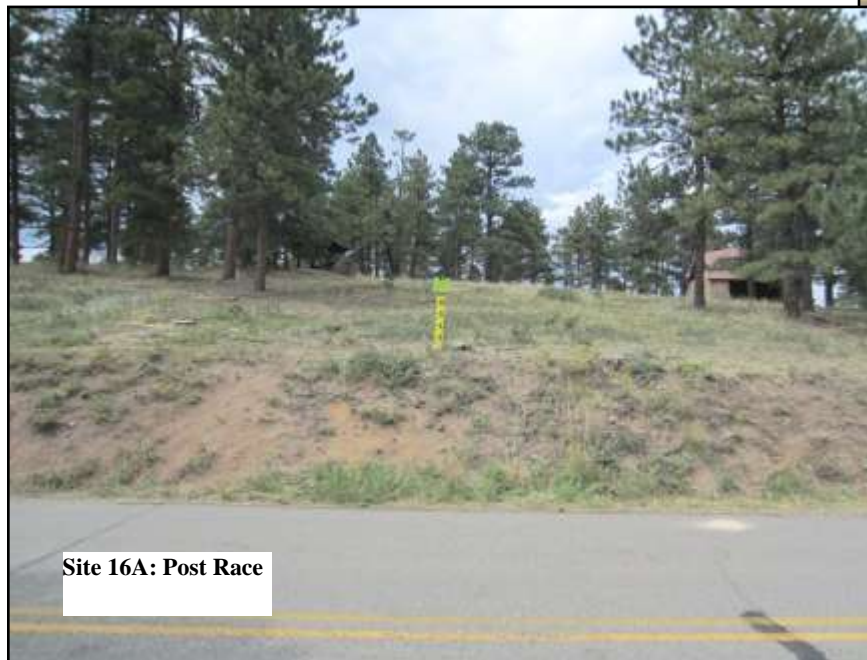
## 2012 USA Pro-Cycle Challenge - Site ID 16A Center

Results: Some noticeable change from finishing corral placement or spectator activity

Note(s): Some vegetation loss and additional exposed soil

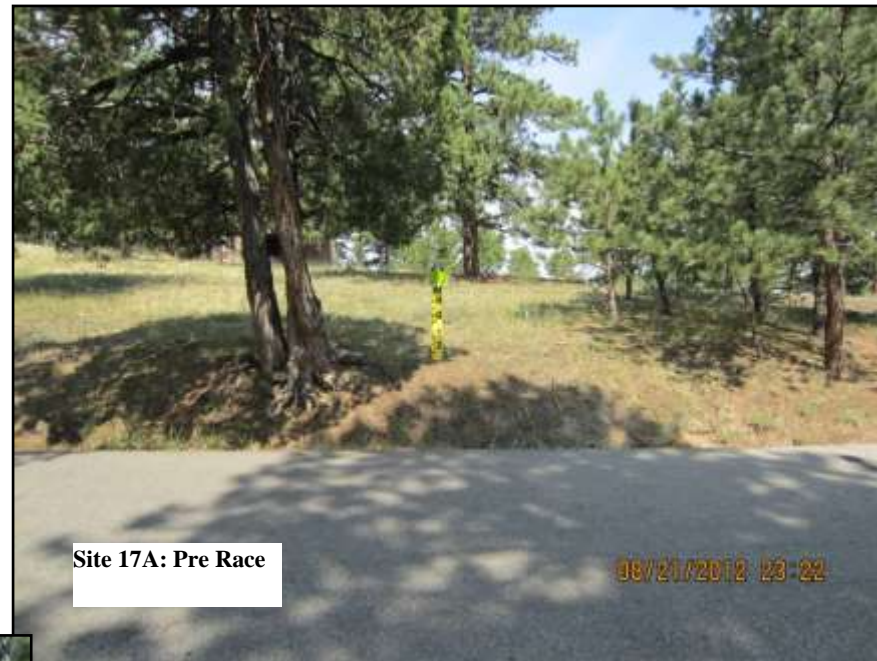
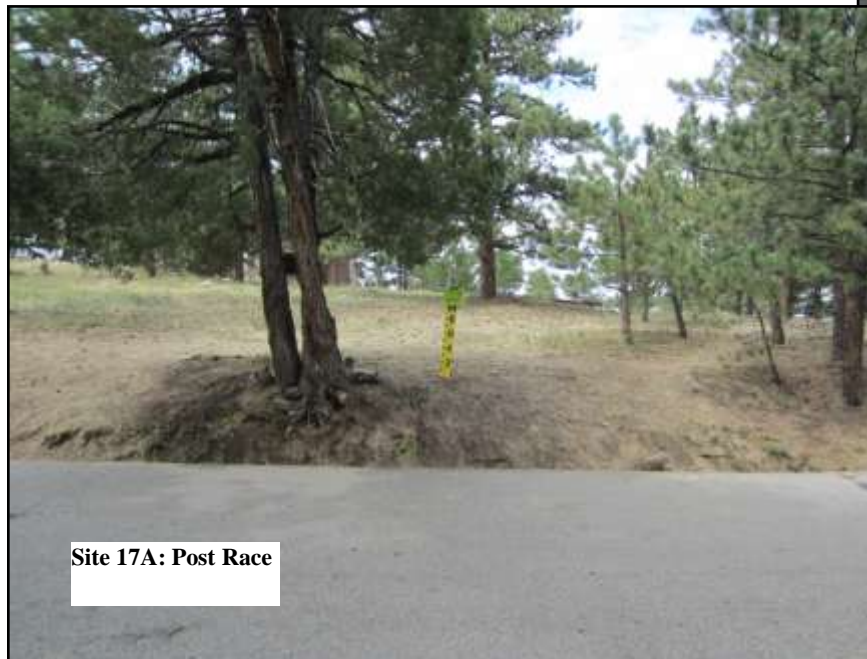
## 2012 USA Pro-Cycle Challenge - Site ID 17A Center

Results: Extensive noticeable change from finishing corral placement, race equipment set-up or spectator activity

Note(s): Widespread vegetation loss and additional exposed soil; race finish area

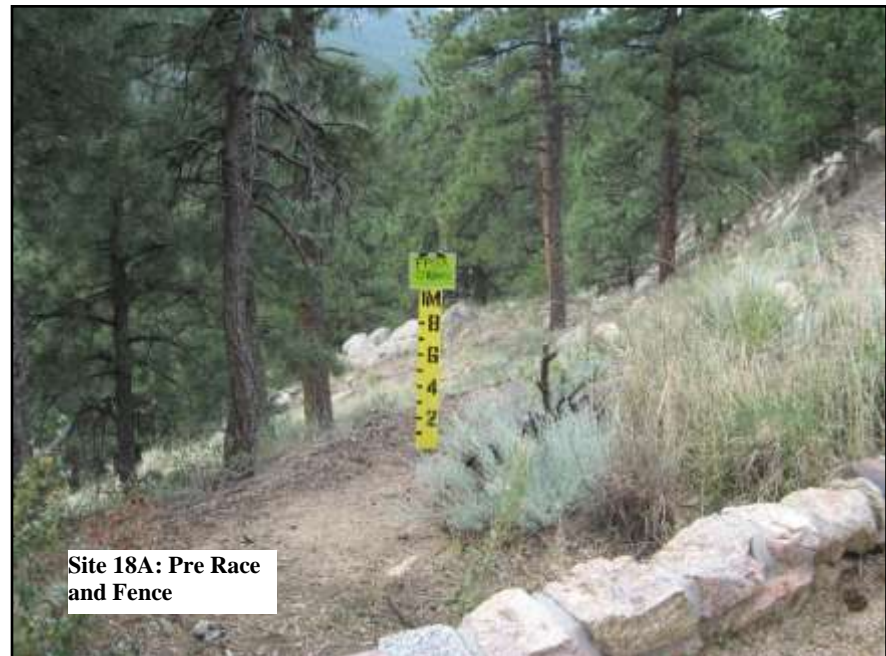
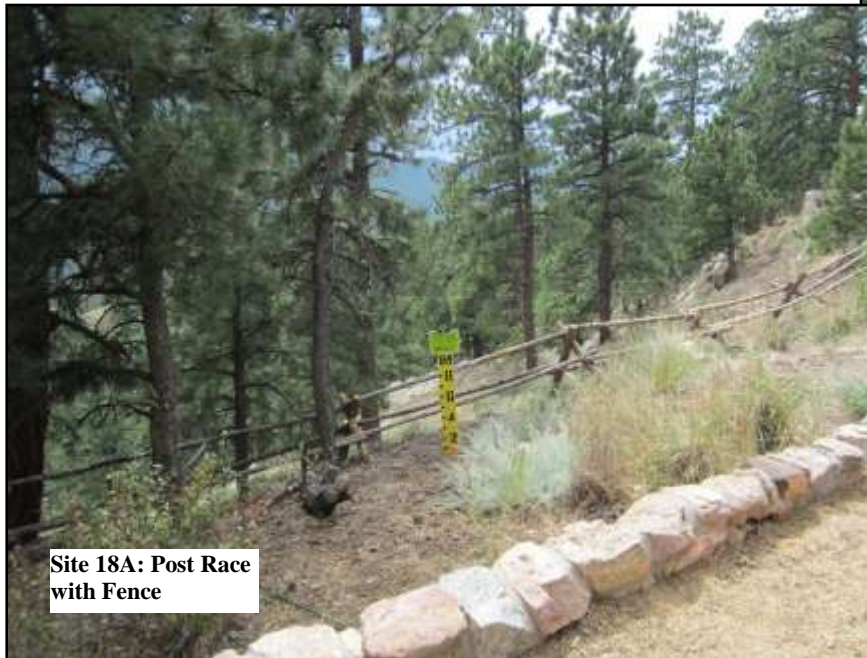
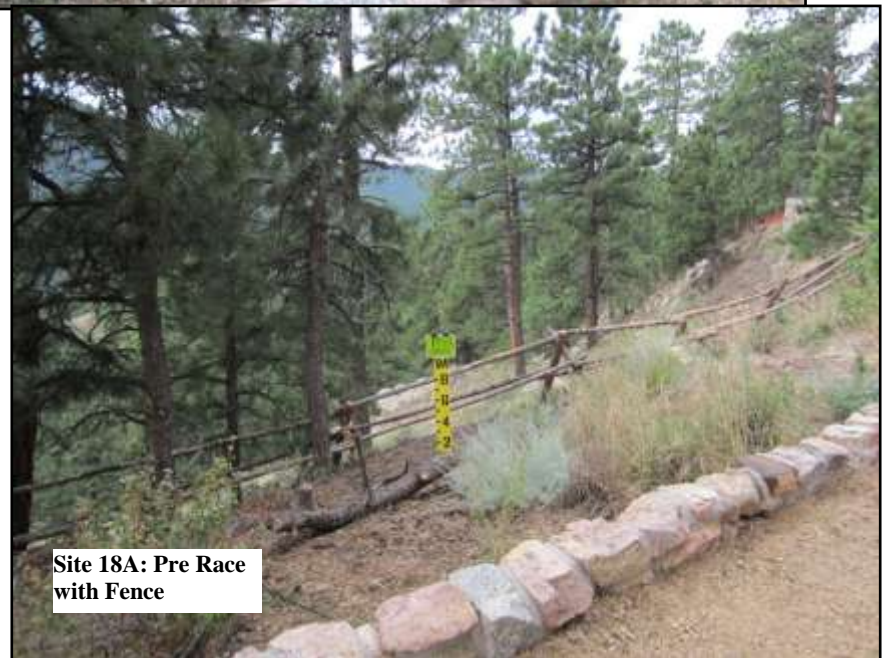
## 2012 USA Pro-Cycle Challenge - Site ID 18A Center

Results: Some noticeable change from fence placement, staff activity or spectator activity

Note(s): OSMP restoration crew disguised social trail with organic materials on-site; slash log moved off-trail

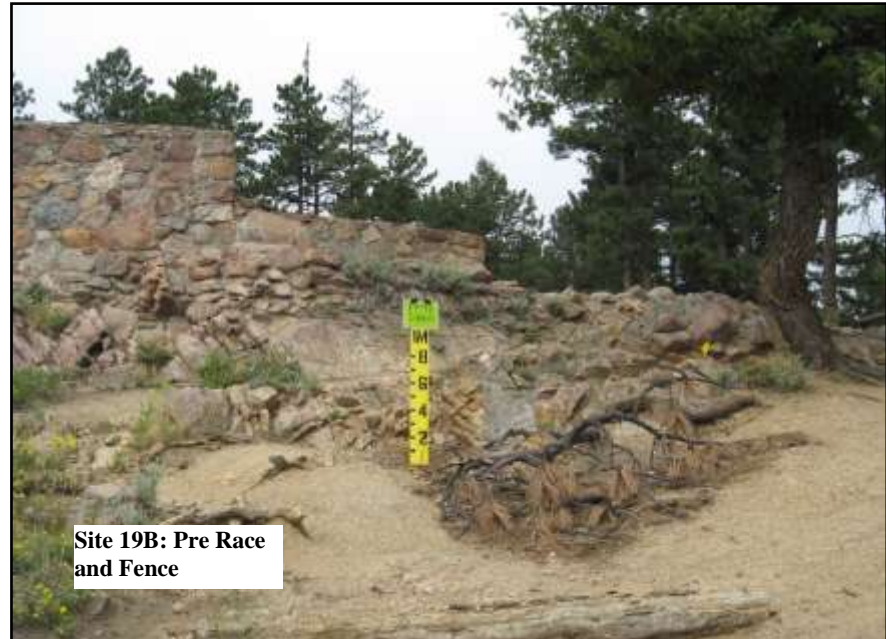
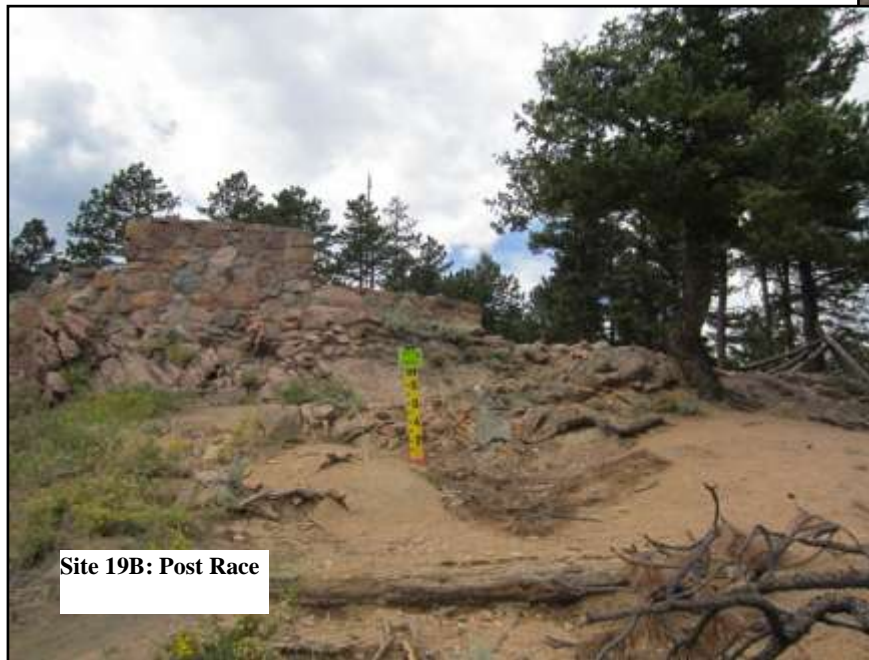
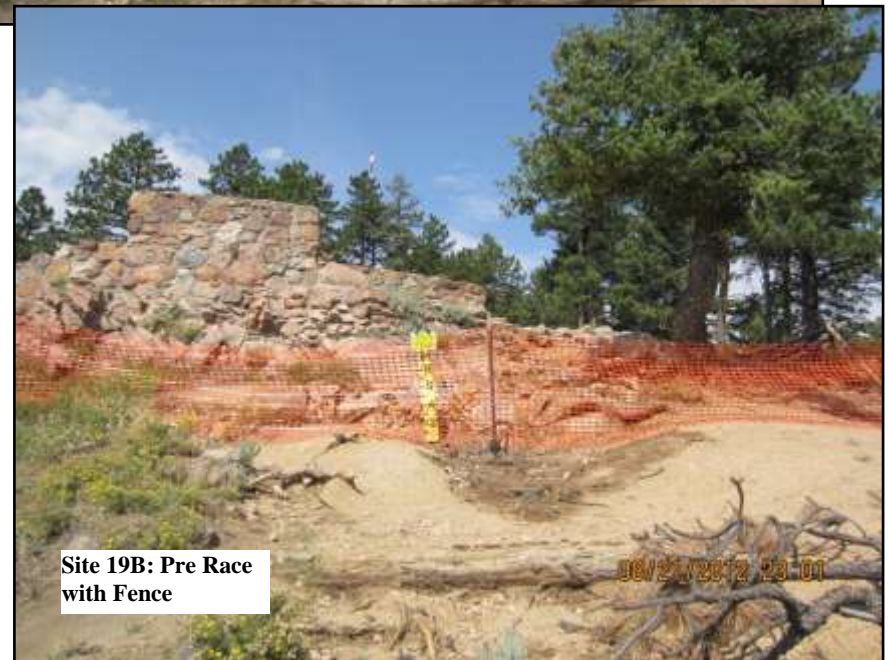
## 2012 USA Pro-Cycle Challenge - Site ID 19B Center

Results: No noticeable effect from fence placement or spectator activity
